Wiginton Orlando
 699 Aero Lane
 Orlando, Florida 32771
 (407) 585-3200

Cust. Name: Bayshore Bath & Tennis Club
 Cust. Id: BAYS0002

Site Name: Bayshore Condo
 Address: 925 N. Halifax Ave
 Daytona Beach, FL 32114
 Address Id: BAY0005

Date: 03-10-2023
 Service Call ID: 221201-1731
 Inspector: Nixon Pena
 Phone: (407) 585-3200
 Email: npena@wiginton.net

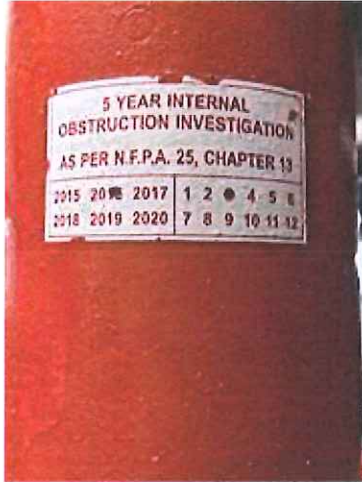
ID: 8040

Due 5 yr inspection

<p>ID: 8040 Deficiency Location: Level A</p>	<p>Deficiency: No record showing 5 year internal inspection of check valve performed</p>
<p>Critical</p>	<p align="center"> ✓ Tag Noncritical Impairment </p>

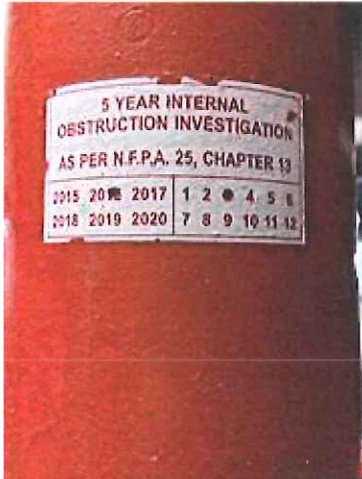
ID: 8440

Deficiency: No record showing 5 year internal inspection of sprinkler piping performed

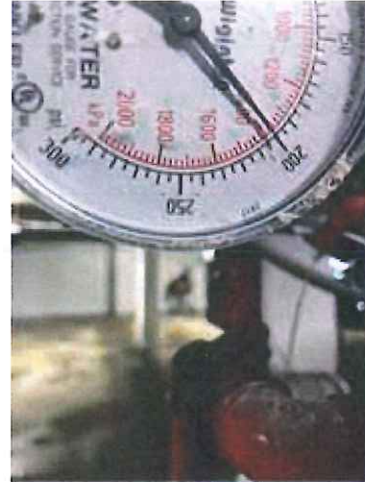
ID: 15300

2017 outdated

<p>ID: 15300 Deficiency Location: Level A</p>	<p>Deficiency: No records available showing gauges having been tested or replaced within the last five years</p>
<p>Critical</p>	<p align="center"> ✓ Tag Noncritical Impairment </p>

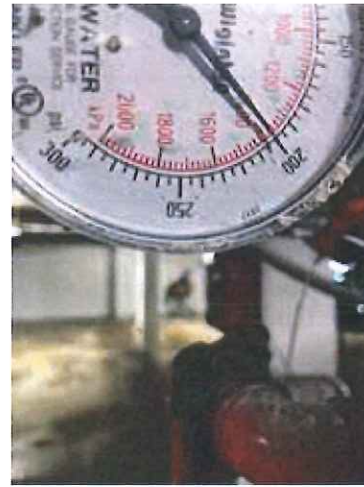
Outdated

ID: 23800	Deficiency: Fire pump system gauges past calibration or replacement date		
Deficiency Location: Pump		Tag	
Critical	✓	Noncritical	Impairment

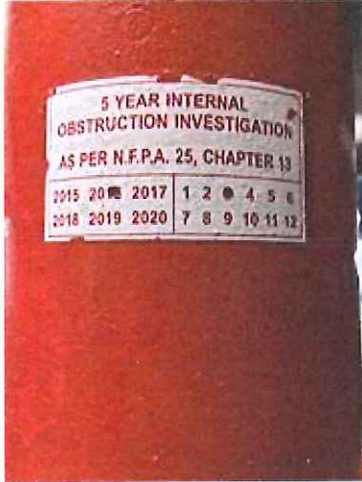
ID: 10900	Deficiency: No record showing five year internal inspection of check valve being performed
Deficiency Location: Tower1,2	
Critical	✓ Tag Noncritical Impairment

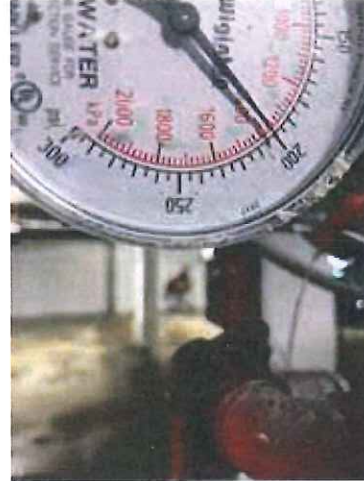
ID: 16200	Deficiency: No records showing gauges being tested or replaced within the last five years
Deficiency Location: Pump	
Critical	✓ Tag Noncritical Impairment

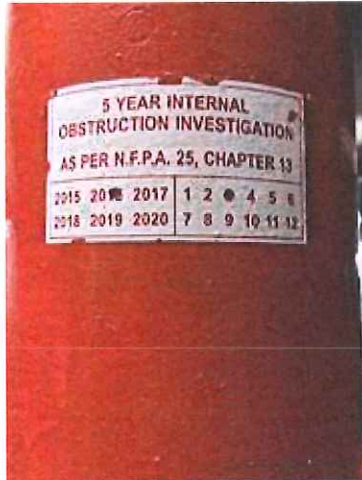
ID: 11600

Deficiency: No record showing five year internal inspection of main, remote hose location and branch line (if present) piping being performed
